Manhole Inspection Summary

Manhole # S45A__018MH

Insp Date: **6/11/08 10:04 AM**

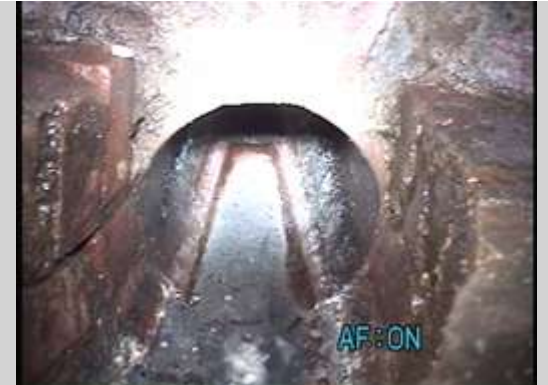
12 O'Clock Outflow

6 in. Circular Gravity Sewer
Pipe Out @ 12 O'Clock

Pipe Height: **8.4** (in.) Rod and Bar (Angled)

Pipe Material: **Clay** ☐ Pipe Lined

Invert Depth: **11.20** (ft.) Flow Characteristics: **Slow**

Deposits: ☒ None ☐ Mud ☐ Sludge ☐ Debris ☐ Grease

Infiltration: **None** Pipe Seal Cond: **Sound**

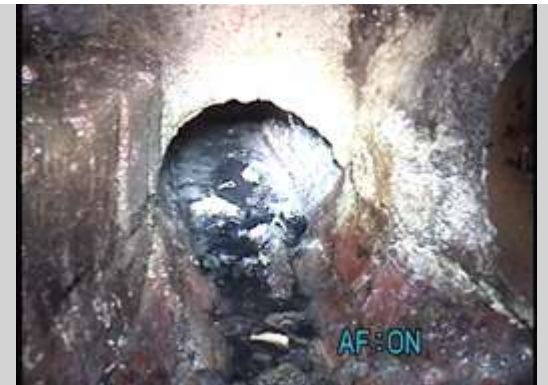
6 O'Clock Inflow

8 in. Circular Gravity Sewer
Pipe In @ 6 O'Clock

Pipe Height: **8.4** (in.) Rod and Bar (Angled)

Pipe Material: **Clay** ☐ Pipe Lined

Invert Depth: **11.15** (ft.) Flow Characteristics: **Slow**

Deposits: ☒ None ☐ Mud ☐ Sludge ☐ Debris ☐ Grease

Infiltration: **None** Pipe Seal Cond: **Sound**

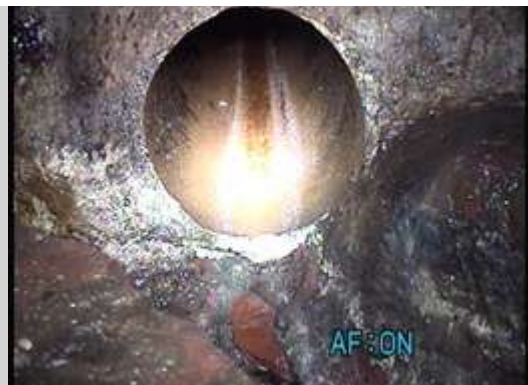
7 O'Clock Inflow

8 in. Circular Gravity Sewer

Pipe In @ 7 O'Clock

Pipe Height: **8.4** (in.) Rod and Bar (Angled)

Pipe Material: **Clay** ☐ Pipe Lined

Invert Depth: **10.90** (ft.) Flow Characteristics: **Slow**

Deposits: ☒ None ☐ Mud ☐ Sludge ☐ Debris ☐ Grease

Infiltration: **None** Pipe Seal Cond: **Sound**
